TEST RESULTS REPORT AND DESIGN TECHNOLOGY DEVELOPMENT REPORT - HLH/ATC
HIGH-SPEED TAPERED ROLLER BEARING
DEVELOPMENT PROGRAM

Boeing Vertol Company

Army Air Mobility Laboratory

June 1974

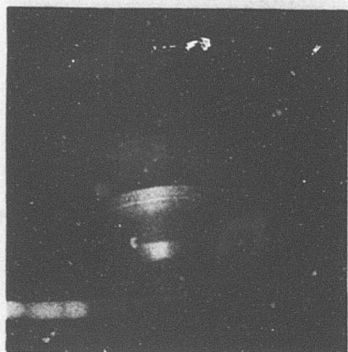
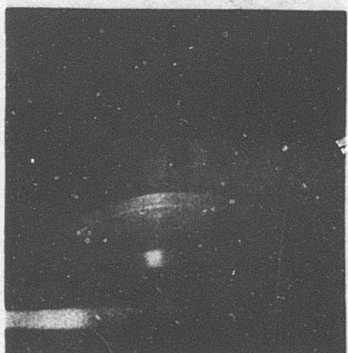
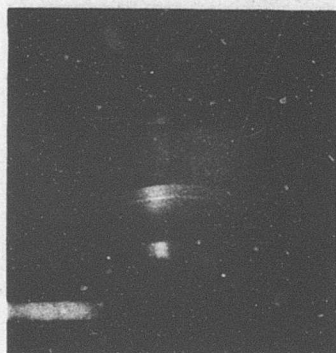
Figure 69. Simulated XC11437 Cone at 3000 rpm--Angle and Length of Oil Hole - 75° , 0.5 Inch ; Oil Flow Rate - 6 Pints per Minute.

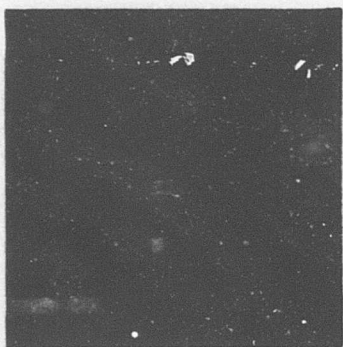
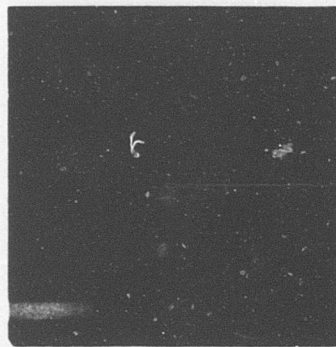
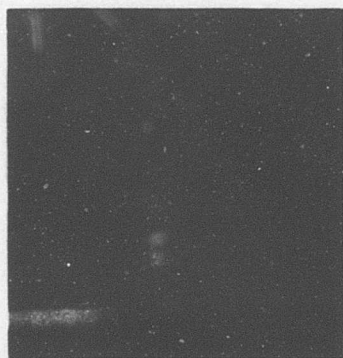
Figure 70. Simulated XC11437 Cone at 8000 rpm--Angle and Length of Oil Hole - 75° , 0.5 Inch ; Oil Flow Rate - 6 Pints per Minute.

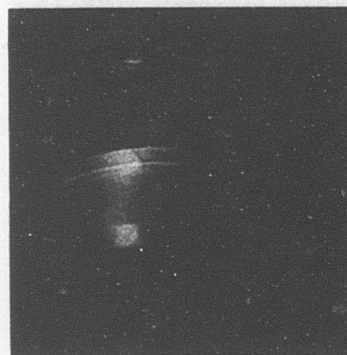
Figure 71. Simulated XC11437 Cone at 3000 rpm--Angle and Length of Oil Hole - 75° , 0.375 Inch; Oil Flow Rate - 6 Pints per Minute.

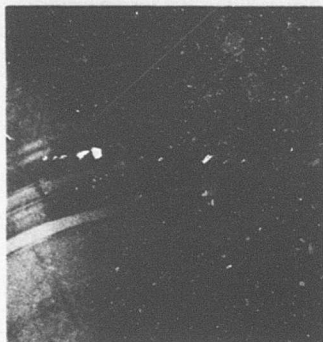
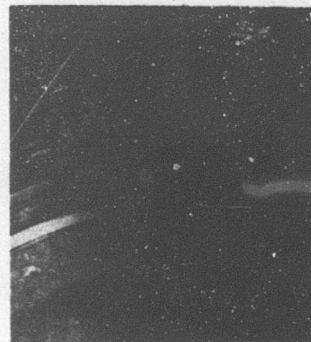
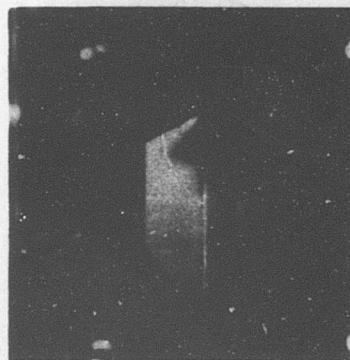
Figure 74. Simulated XC12088 Cone at 2000 rpm--Angle and Length of Oil Hole - 75° , 0.32 Inch; Oil Flow Rate - 3 Pints per Minute.

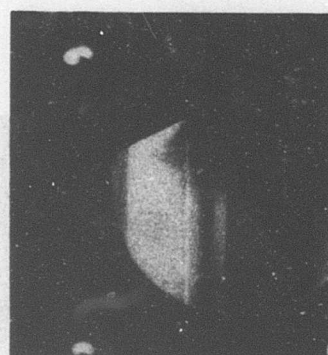
Figure 75. Simulated XCl2088 Cone at 2000 rpm--Angle and Length of Oil Hole - 75° , 0.32 Inch; Oil Flow Rate - 3 Pints per Minute.

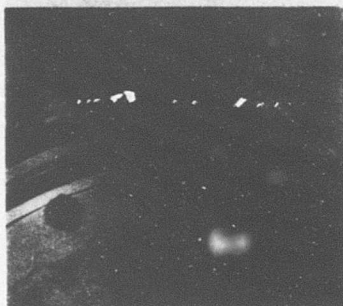
Figure 76. Simulated XCl2088 Cone at 3000 rpm--Angle and Length of Oil Hole - 75° , 0.32 Inch; Oil Flow Rate - 3 Pints per Minute.

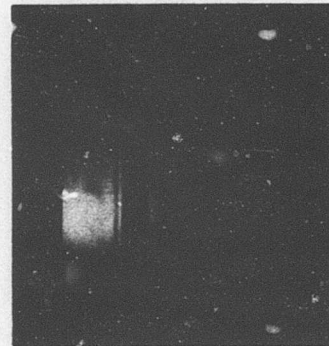
Figure 80. Simulated XC12088 Cone at 1000 rpm--Angle and Length of Oil Hole - 75°, 0.225 Inch; Oil Flow Rate - 3 Pints per Minute.

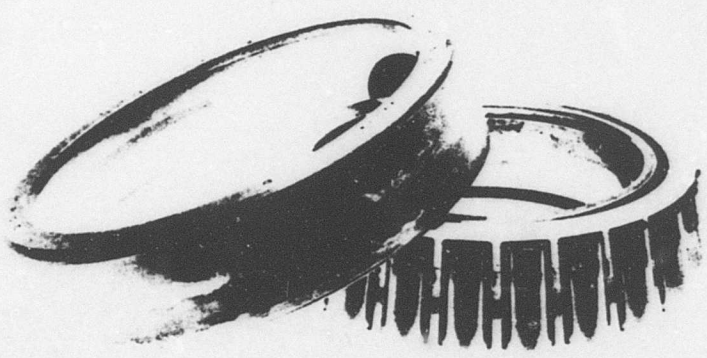
Figure 87. Drive End Center Bearing S/N 73-59 After Test.

The bearings were disassembled and visually inspected for any evidence of fatigue or wear. Figures 86, 87, 88 and 89 show the overall condition of the bearings prior to disassembly of the cage and rollers from the cone. Table XIV provides a summary of the visual examination of all components of the four test bearings. In addition, Figures 90 through 105 show photographs of the condition of each component at the completion of the test. All cups of the test bearings had slight evidence of the initiation of surface damage in the form of small surface pits and some peeling. The pits were smaller than .01 square inch in area. The peeling or superficial surface distress is a mode of damage associated with marginal oil film thickness which usually occurs around bruises, grooves or ends of cup-roller or cone-roller contacts. This type of bearing damage has also been observed on CH-46 and CH-47 transmission bearings using synthetic lubricants without major influence on bearing removals. The peeling observed in the test bearings appeared to be localized in areas of high stress. Similar type of peeling damage was noted near the under cut groove and cone-roller contact area on three of the four cones. One roller from bearing serial number 73-69/73-27 also showed several tiny surface pits which

The conditions of all four bearings were very similar and mainly consisted of several small pits (less than .01 square inch in area), peeling, and light debris damage. This damage appears to be associated with thin oil films in areas of high load concentration.
